CORRESPONDENCE FROM THE APPLICANT

RE; 1187 Coast Village Road, Montecito.

1187 Coast Village Road – Canary Island Pine Trees (*Pinus Canariensis*)

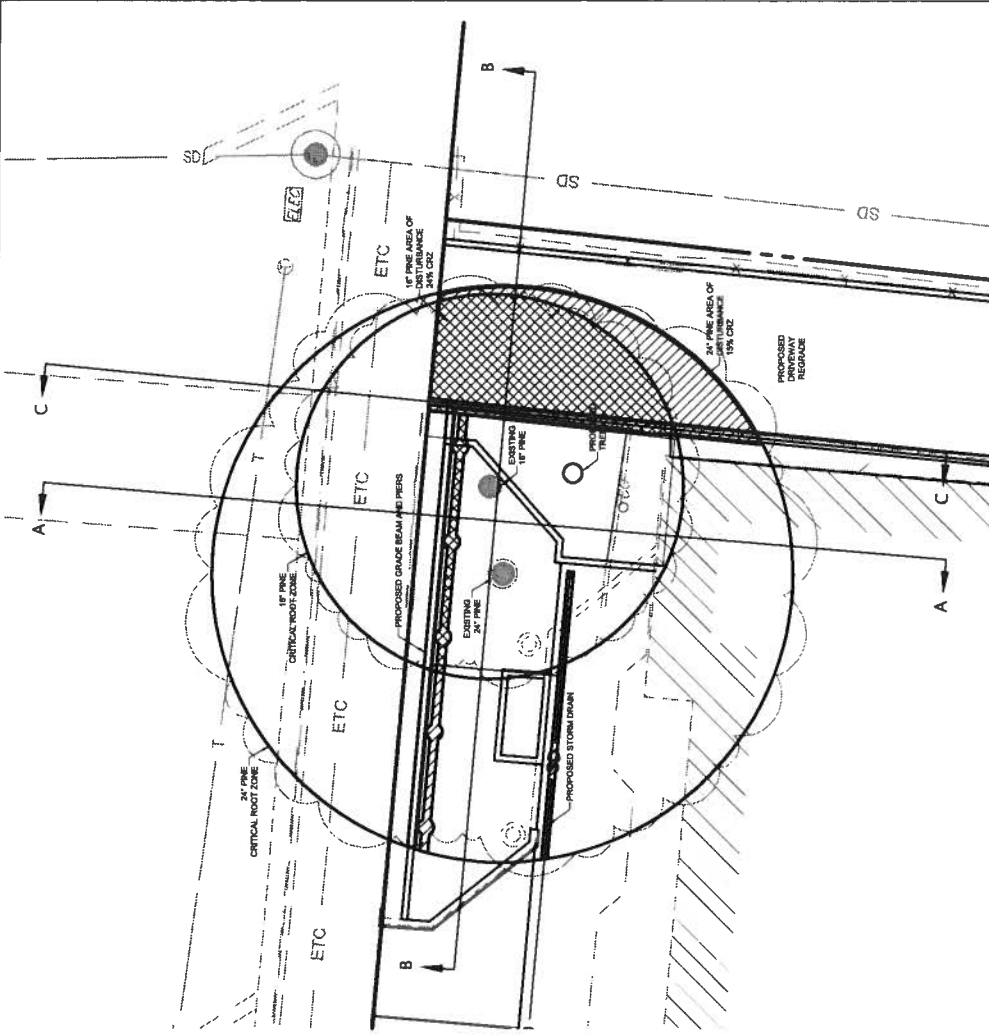
The other two 24" dbh Pines located on the northeast corner of the property adjacent to Coast Village Road are not good specimens due to structural imperfections. Superficially, as you glance at the trees that have formed one canopy they appear to be worthy skyline trees but upon closer examination I found this not to be the case. My primary concern is with the larger of the two trees closest to the building, it has two stems (commonly called codominant stems)

starting at about 6ft. Unfortunately, this is an extremely hazardous condition as the two stems have a tendency to split apart at any time and as the tree continues to grow and expand its trunk girth, there is a greater chance of failure. Given the surrounding target area of buildings, public streets, cars and pedestrians, I have to recommend its removal regardless of the any impact from the proposed project. Please see the attached site photographs, Attachment B.

The remaining third 16" dbh Pine tree adjacent to the twin-stemmed Pine does have a lean to the east and all of its branches are on the east side of the tree due to being suppressed by its partner tree. Given I recommended the removal of the twin-stemmed tree, the remaining Pine will not only look out of place but will be susceptible to failure due to its weighted lean to the east and will be far more vulnerable to wind-throw. I feel it prudent to remove this tree also and replace with a new specimen tree in the same general location.

Existing 16" dbh and 24" dbh Canary Island Pines located on the northeast corner of the subject property
